Application note

No. 14

Ultra-high speed video camera captures image for 2D DiC measurements

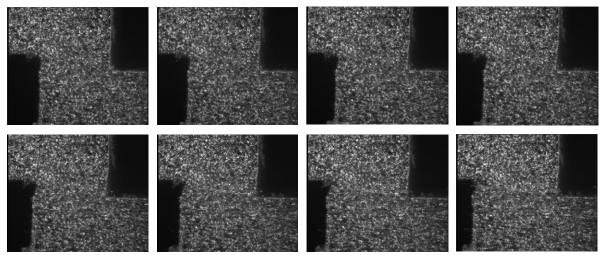
Images Courtesy of Nordmetall GmbH

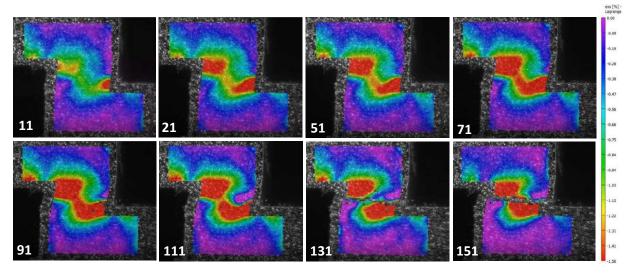
The imaging results were analysed using Correlated Solutions Vic-2D DIC software. The above analysis show exx lagrange strain (strain in the same direction of motion) for the same images shown previously.

Maximum strain is denoted by the regions of red, this corresponds to a strain percentage change of 1.5%. The areas of minimum strain are shown in purple, in these regions there is zero stain in the x-direction.

From the first image, it is clear a shear band of heightened strain occurs at approximately 45° to normal. As the specimen begins to 'slide' relative to itself, pure shear is induced, starting from the outside edges and converging in the centre. This is shown right:

In an adiabatic shear test such as this, the strain localises along precise shear bands. This occurs due to high-strain rate loading giving rise to localised heat concentrations which do not have time to conduct in the bulk material. This high temperature 'band' deforms far more readily than the cooler bulk material. In a slower, more static test the strain field would be less localised, due to these isothermal conditions.

Images 131 and 151 exhibit specimen failure. As cracks occur on the surface the 'speckle pattern' used to gather DIC results is interrupted. This interruption does however provide the opportunity to track crack formation and propagation. As would be expected, the crack propagates from the outside edge of the specimen and moves horizontally through the centre of the shear region.
